5. Warrensville Center Road and Traymore Road and Hillbrook Road Intersections

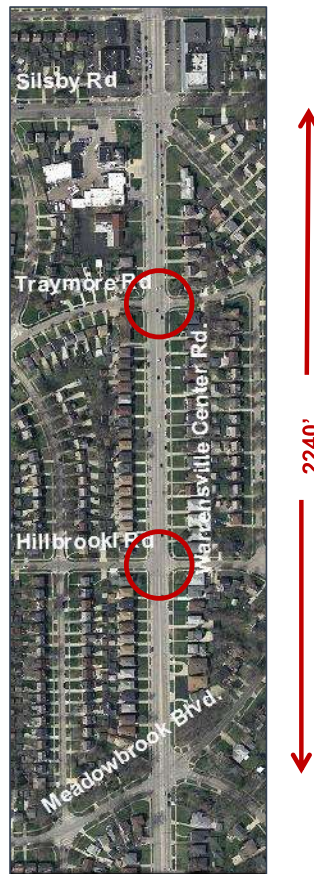
Figure 13: Warrensville Center Road

The lack of mid-block pedestrian crossings is evident along Warrensville Center Road. The distance between the two closest crosswalks between Silsby Road and Meadowbrook Blvd. is 0.42 miles (2,240 feet) (see Figure 13). There are no east-west crosswalks at the stop-controlled intersections of Warrensville Center Road with Hillbrook Road and Traymore Road. In addition to the midblock crossing recommended between Traymore Road and Hillbrook Road, this study recommends:

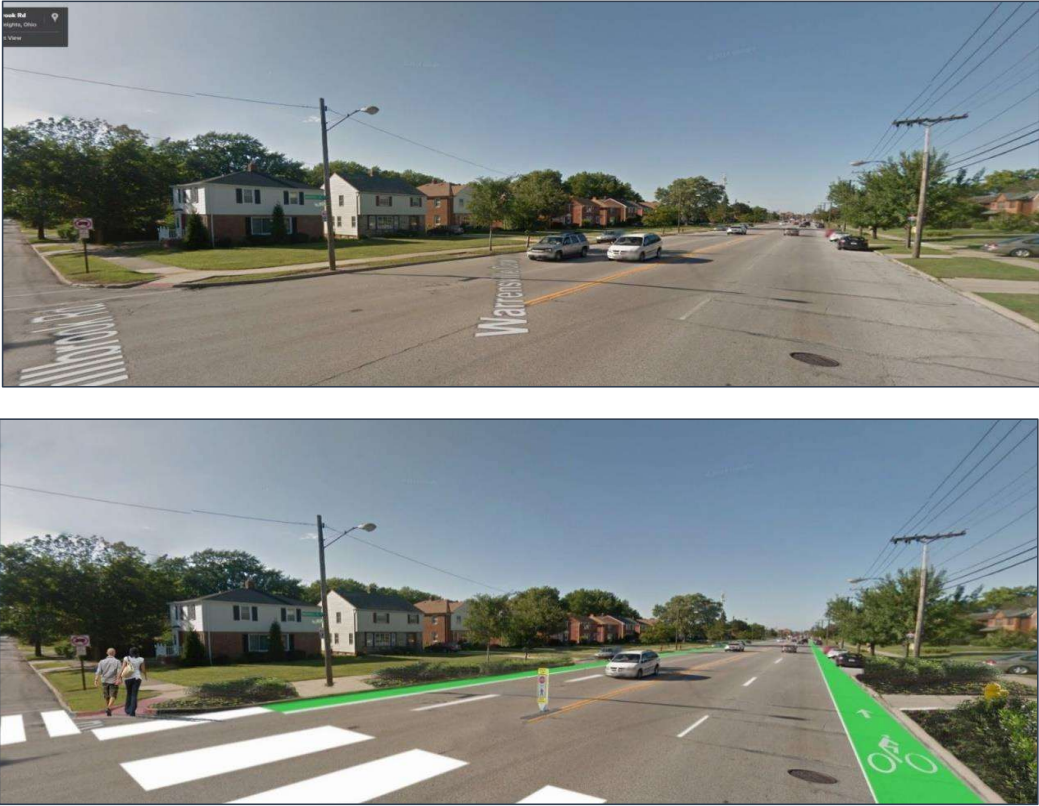
Figure 15: Existing and proposed Hillbrook Road intersection

Figure 15 shows a view of the existing south corners of the Hillbrook Road intersection and the proposed curb extensions and pedestrian crossings.
